ADDENDUM NO. 4

San Rafael City Schools Terra Linda High School Innovation Hub

Project: Terra Linda High School
Innovations Hub
320 Nova Albion Way
San Rafael, CA 94903

AD-4.B02 Document 00 31 26 – Existing Hazardous Material Information: "Limited Pre-Renovation Hazardous Materials Report" Prepared by Terracon Consultants, Inc. dated February 5, 2018 is attached. Hazardous materials abatement is required within the area of work as detailed in the hazardous material report except for the carpet mastic in room 109.

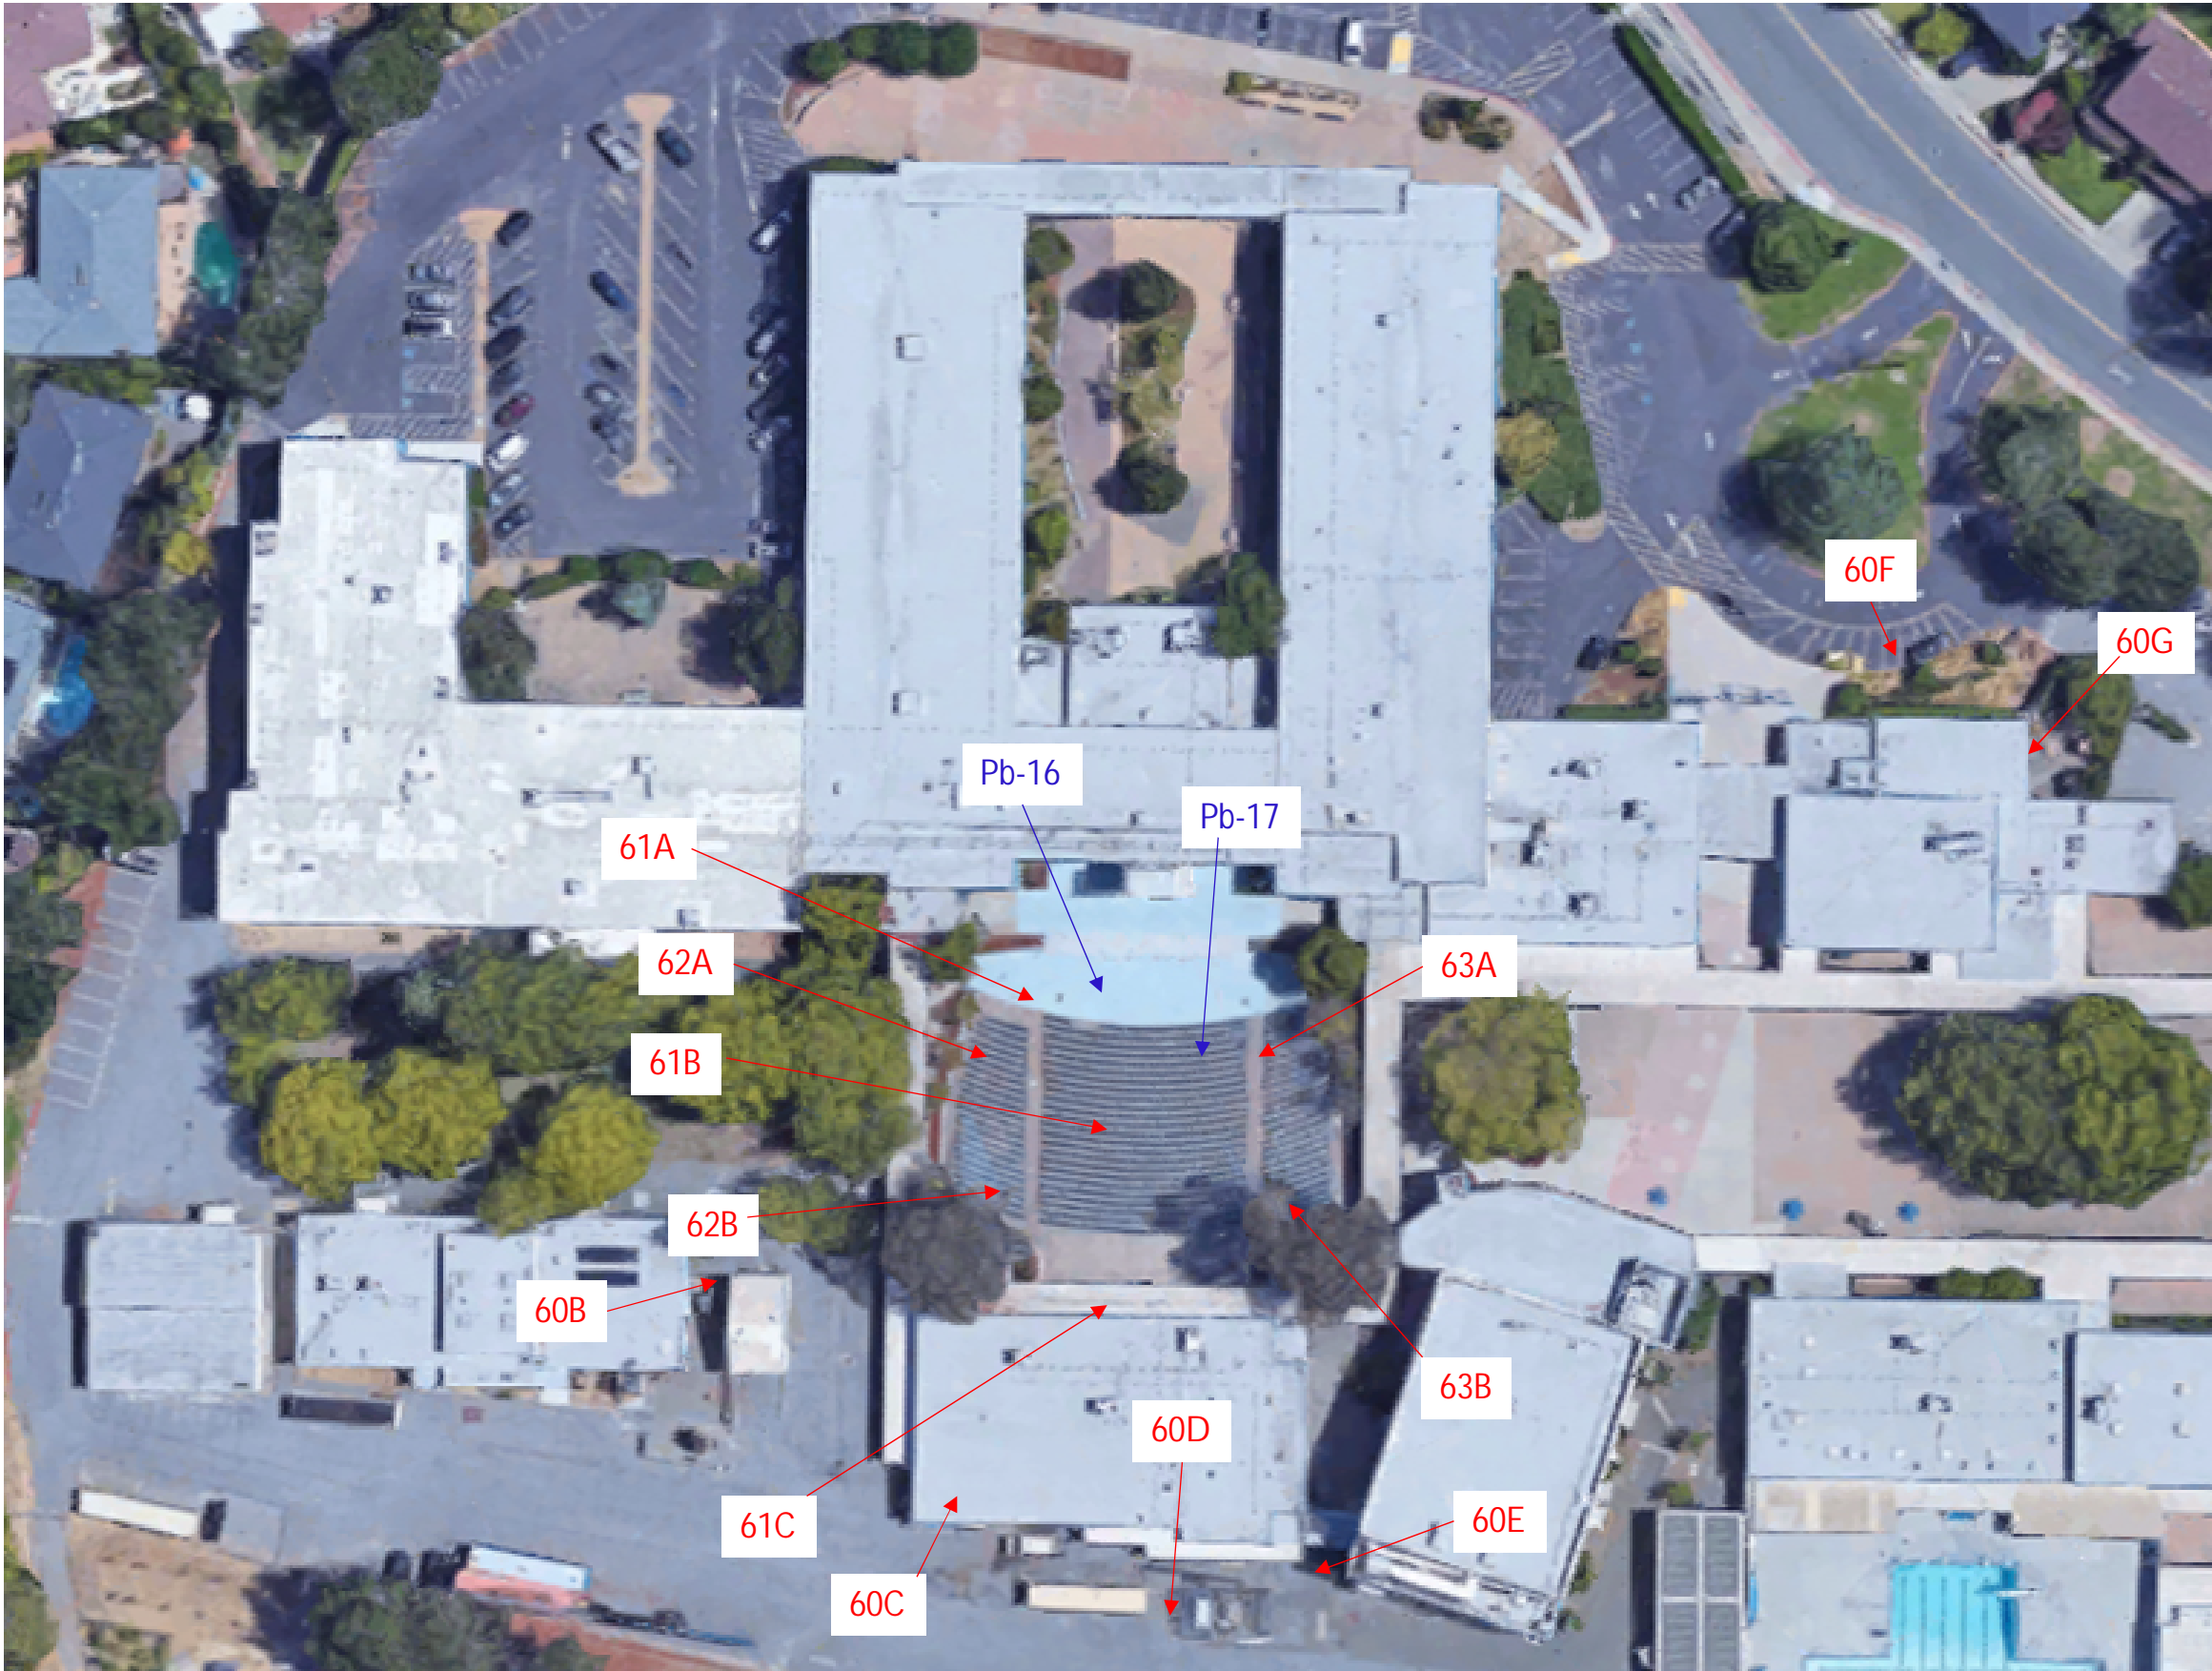
<u>Date</u> January 2018	<u>Drafted By</u> WMF
<u>Project Number</u> R1177466	<u>Checked By</u> SPS
<u>Sheet Name</u> Common Exterior Areas - Sample Locations	
<u>Sheet Number</u> Figure 4
